Asbestos Refurbishment/Demolition Survey for

Gotherington Church Centre

Project Number: 1001435

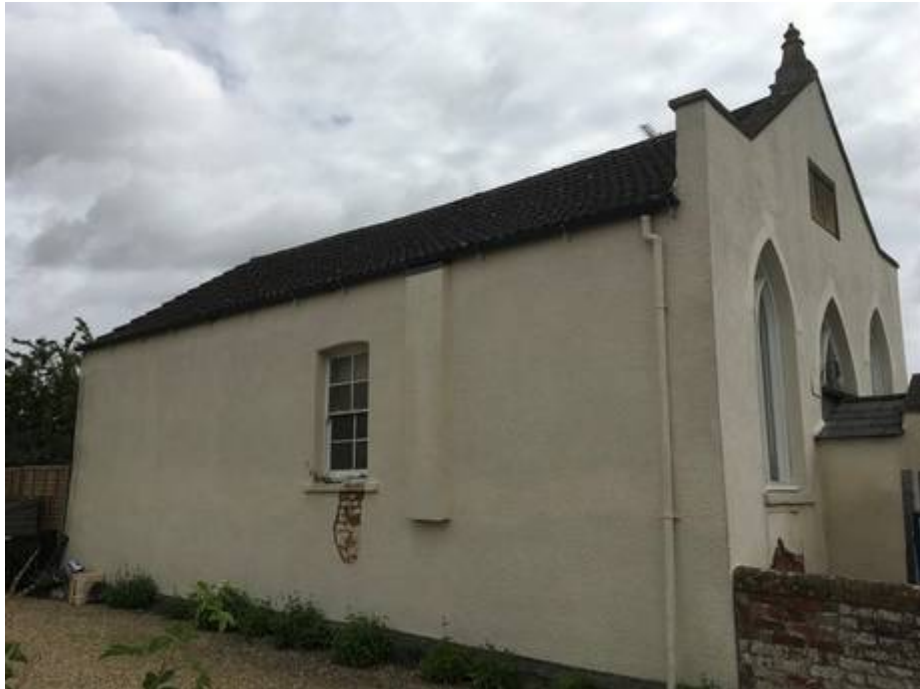
Location ID:	6082	Survey Type:	RDS
Location Ref:	1	Product Type:	Not Applicable
Product:	Roof Tiles	Damage:	Not Applicable
Area:	Gotherington Church Centre	Treatment:	Not Applicable
Floor:	External	Asbestos Type:	Not Applicable
Room:	Roof	Identification:	
Surveyor Name:	Rob Letman	Quantity:	
Drawing Ref:			
Asbestos ?	No		
Date:	14 August 2017		
Next Inspection:	Not Applicable

Roof tiles appear to be non-asbestos material

No Action Required

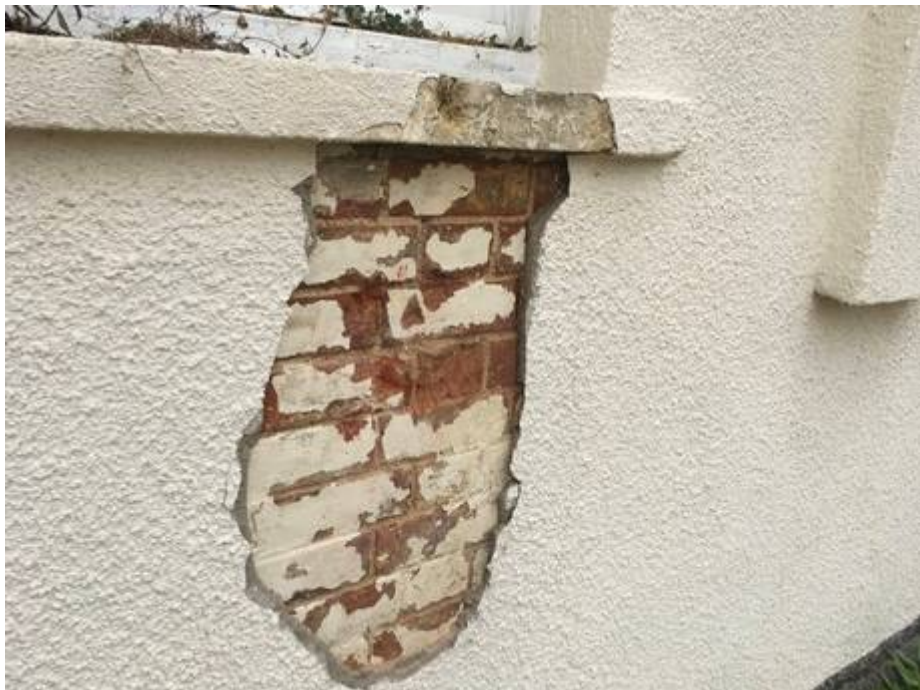
Location ID:	<input type="text" value="6083"/>	Survey Type:	<input type="text" value="RDS"/>
Location Ref:	<input type="text" value="2"/>	Product Type:	<input type="text" value="Not Applicable"/>
Product:	<input type="text" value="Textured coating"/>	Damage:	<input type="text" value="Not Applicable"/>
Area:	<input type="text" value="Gotherington Church Centre"/>	Treatment:	<input type="text" value="Not Applicable"/>
Floor:	<input type="text" value="External"/>	Asbestos Type:	<input type="text" value="Not Applicable"/>
Room:	<input type="text" value="Render to walls"/>	Identification:	<input type="text"/>
Surveyor Name:	<input type="text" value="Rob Letman"/>	Quantity:	<input type="text"/>
Drawing Ref:	<input type="text"/>		
Asbestos ?	<input type="text" value="No"/>		
Date:	<input type="text" value="14 August 2017"/>		
Next Inspection:	<input type="text" value="Not Applicable"/>

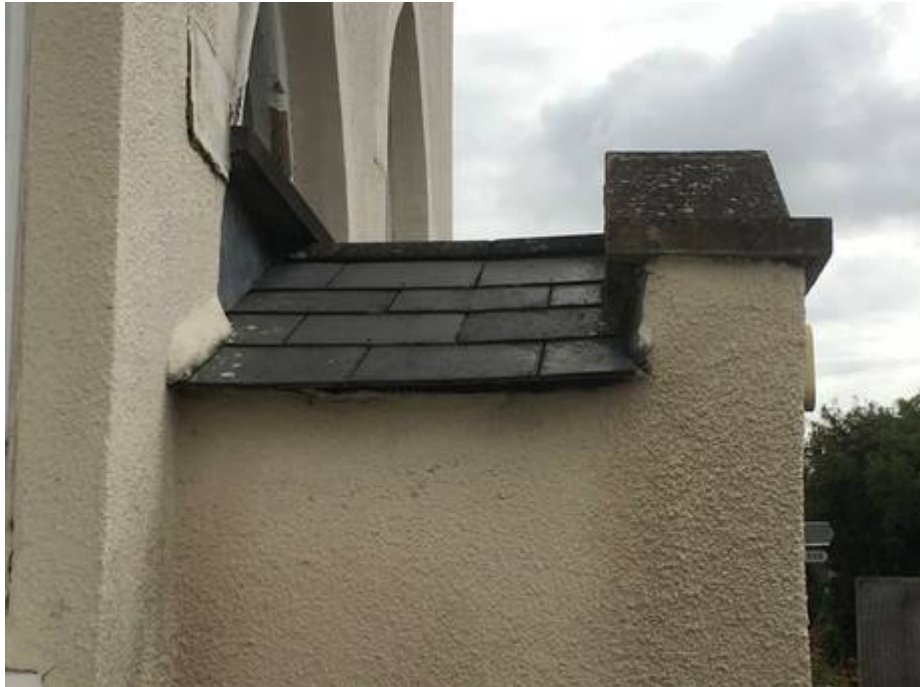
Location ID:	6084	Survey Type:	RDS
Location Ref:	3	Product Type:	Asbestos cement
Product:	Sheeting	Damage:	Low damage
Area:	Gotherington Church Centre	Treatment:	Asbestos cement sheets etc
Floor:	External	Asbestos Type:	Chrysotile
Room:	Front entrance	Identification:	Identified
Surveyor Name:	Rob Letman	Quantity:	Approx 1m ²
Drawing Ref:			
Asbestos ?	Yes		
Date:	14 August 2017		
Next Inspection:	14 August 2018

Needs to be removed prior to refurbishment works

Remove and dispose of the asbestos materials if affected by refurbishment or demolition works in accordance with current Control of Asbestos Regulations 2012.

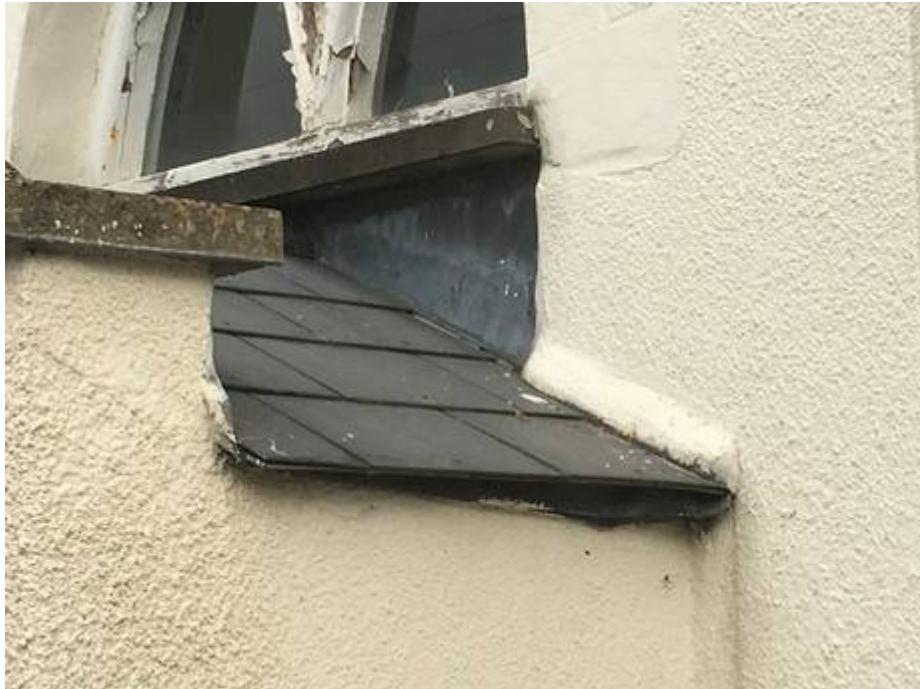
Location ID:	<input type="text" value="6085"/>	Survey Type:	<input type="text" value="RDS"/>
Location Ref:	<input type="text" value="4"/>	Product Type:	<input type="text" value="Asbestos cement"/>
Product:	<input type="text" value="Sheeting"/>	Damage:	<input type="text" value="Low damage"/>
Area:	<input type="text" value="Gotherington Church Centre"/>	Treatment:	<input type="text" value="Asbestos cement sheets etc"/>
Floor:	<input type="text" value="External"/>	Asbestos Type:	<input type="text" value="Chrysotile"/>
Room:	<input type="text" value="Front entrance"/>	Identification:	<input type="text" value="Identified"/>
Surveyor Name:	<input type="text" value="Rob Letman"/>	Quantity:	<input type="text" value="Approx 1m<sup>2</sup>"/>

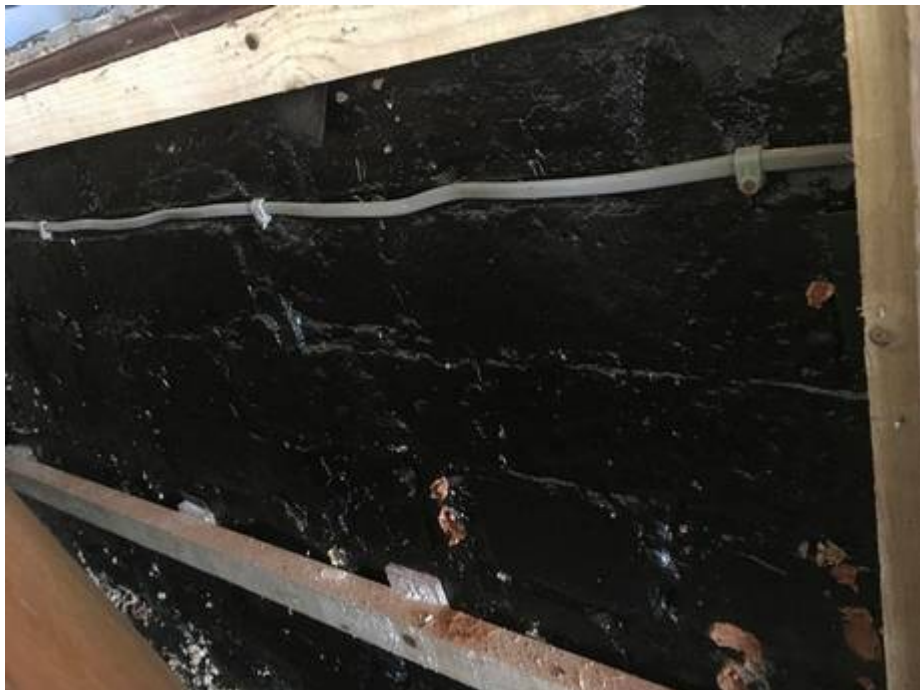
Location ID:	<input type="text" value="6086"/>	Survey Type:	<input type="text" value="RDS"/>
Location Ref:	<input type="text" value="5"/>	Product Type:	<input type="text" value="Not Applicable"/>
Product:	<input type="text" value="Bitumen"/>	Damage:	<input type="text" value="Not Applicable"/>
Area:	<input type="text" value="Gotherington Church Centre"/>	Treatment:	<input type="text" value="Not Applicable"/>
Floor:	<input type="text" value="Ground floor"/>	Asbestos Type:	<input type="text" value="Not Applicable"/>
Room:	<input type="text" value="Walls"/>	Identification:	<input type="text"/>
Surveyor Name:	<input type="text" value="Rob Letman"/>	Quantity:	<input type="text"/>
Drawing Ref:	<input type="text"/>		
Asbestos ?	<input type="text" value="No"/>		
Date:	<input type="text" value="14 August 2017"/>		
Next Inspection:	<input type="text" value="Not Applicable"/>

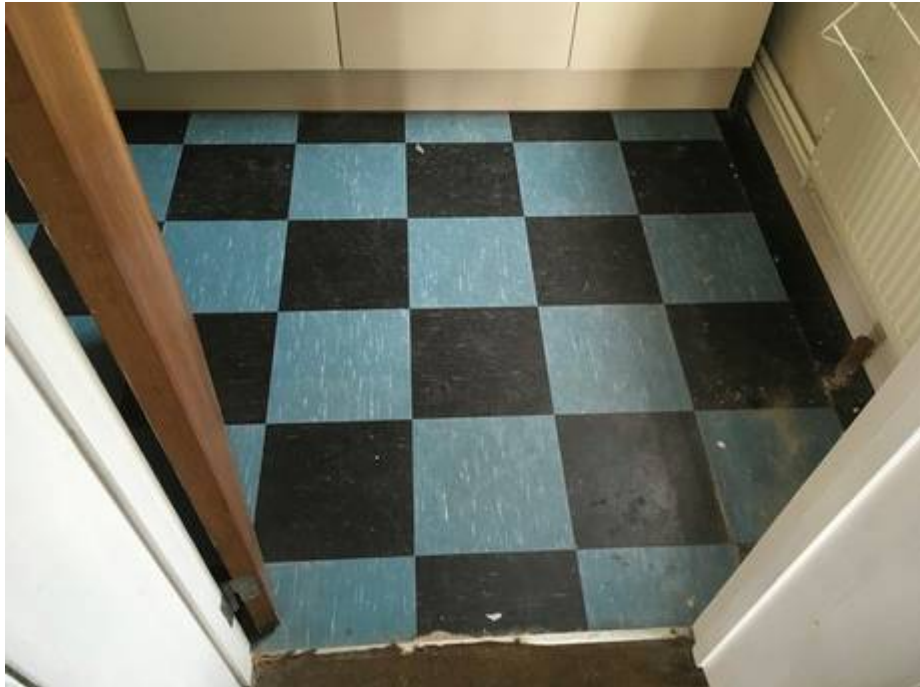
Location ID:	6087	Survey Type:	RDS
Location Ref:	6	Product Type:	Vinyl floor tiles
Product:	Vinyl Floor Tiles	Damage:	Low damage
Area:	Gotherington Church Centre	Treatment:	Vinyl tiles
Floor:	Ground floor	Asbestos Type:	Chrysotile
Room:	Kitchen	Identification:	Identified
Surveyor Name:	Rob Letman	Quantity:	Approx 3m ²
Drawing Ref:			
Asbestos ?	Yes		
Date:	14 August 2017		
Next Inspection:	14 August 2018

Needs to be removed prior to refurbishment works

Floor tiles & bitumen, Remove and dispose of the asbestos materials if affected by refurbishment or demolition works in accordance with current Control of Asbestos Regulations 2012.

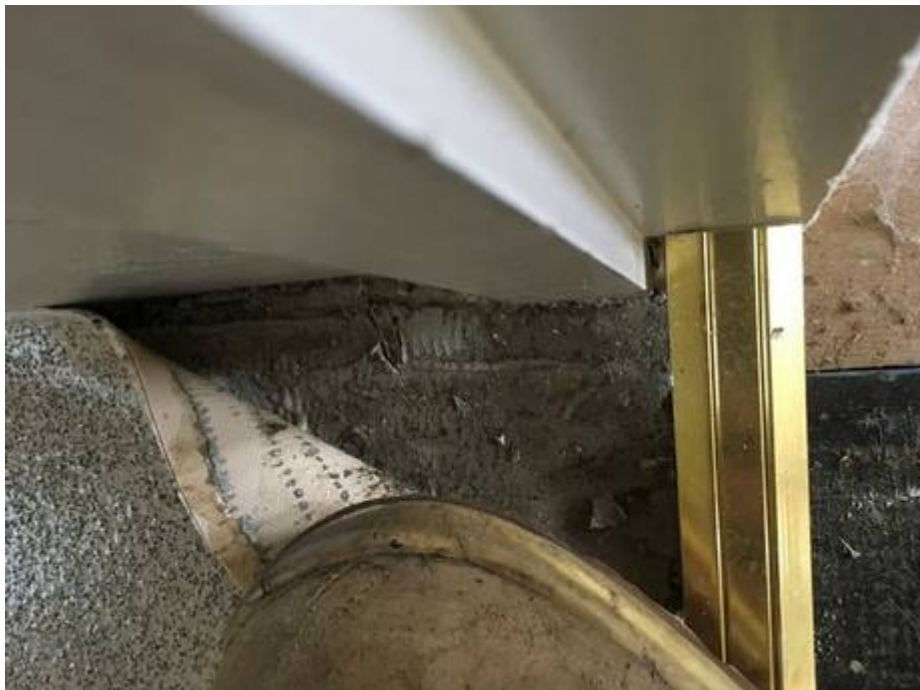
Location ID:	<input type="text" value="6088"/>	Survey Type:	<input type="text" value="RDS"/>
Location Ref:	<input type="text" value="7"/>	Product Type:	<input type="text" value="Not Applicable"/>
Product:	<input type="text"/>	Damage:	<input type="text" value="Not Applicable"/>
Area:	<input type="text" value="Gotherington Church Centre"/>	Treatment:	<input type="text" value="Not Applicable"/>
Floor:	<input type="text" value="Ground floor"/>	Asbestos Type:	<input type="text" value="Not Applicable"/>
Room:	<input type="text" value="WC"/>	Identification:	<input type="text"/>
Surveyor Name:	<input type="text" value="Rob Letman"/>	Quantity:	<input type="text"/>
Drawing Ref:	<input type="text"/>		
Asbestos ?	<input type="text" value="No"/>		
Date:	<input type="text" value="14 August 2017"/>		
Next Inspection:	<input type="text" value="Not Applicable"/>

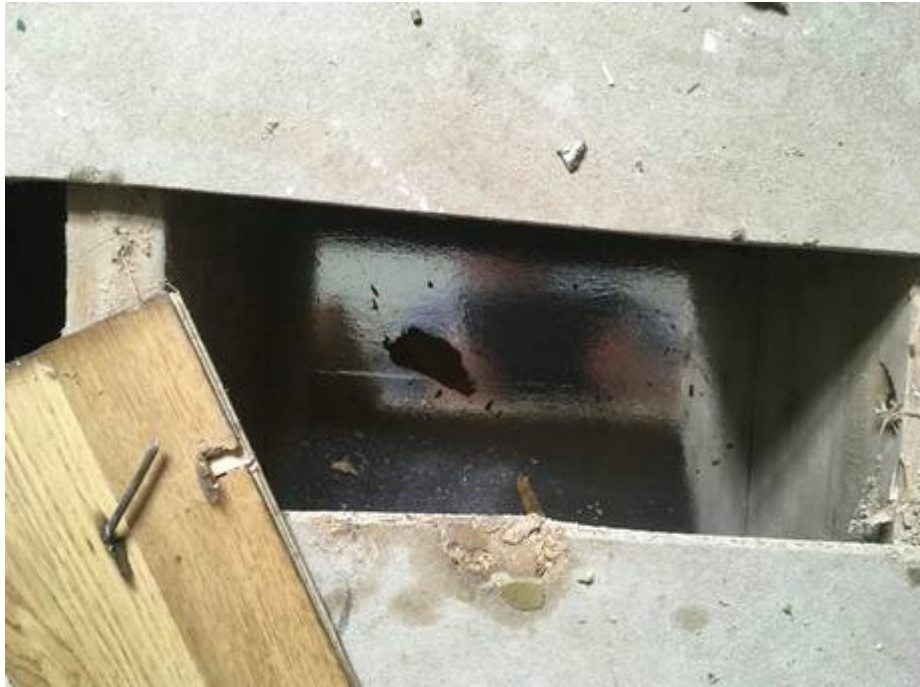
Location ID:	<input type="text" value="6089"/>	Survey Type:	<input type="text" value="RDS"/>
Location Ref:	<input type="text" value="8"/>	Product Type:	<input type="text" value="Not Applicable"/>
Product:	<input type="text"/>	Damage:	<input type="text" value="Not Applicable"/>
Area:	<input type="text" value="Gotherington Church Centre"/>	Treatment:	<input type="text" value="Not Applicable"/>
Floor:	<input type="text" value="First floor"/>	Asbestos Type:	<input type="text" value="Not Applicable"/>
Room:	<input type="text" value="Under floor boards"/>	Identification:	<input type="text"/>
Surveyor Name:	<input type="text" value="Rob Letman"/>	Quantity:	<input type="text"/>
Drawing Ref:	<input type="text"/>		
Asbestos ?	<input type="text" value="No"/>		
Date:	<input type="text" value="14 August 2017"/>		
Next Inspection:	<input type="text" value="Not Applicable"/>

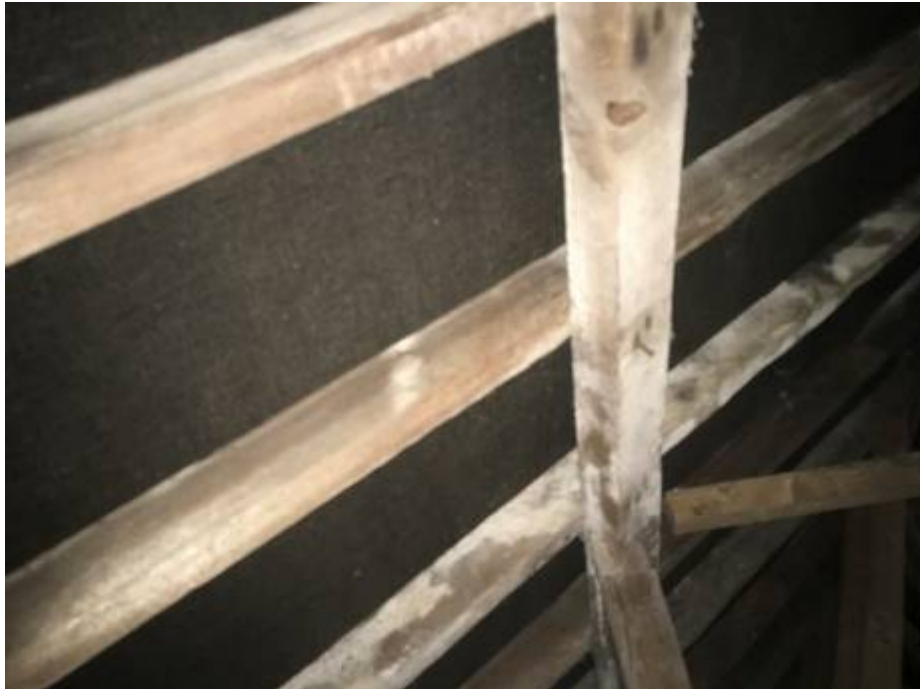
Location ID:	6090	Survey Type:	RDS
Location Ref:	9	Product Type:	Not Applicable
Product:	Bitumen	Damage:	Not Applicable
Area:	Gotherington Church Centre	Treatment:	Not Applicable
Floor:	Roof level	Asbestos Type:	Not Applicable
Room:	Loft space	Identification:	
Surveyor Name:	Rob Letman	Quantity:	
Drawing Ref:			
Asbestos ?	No		
Date:	14 August 2017		
Next Inspection:	Not Applicable

No asbestos found in product no further action required.

No Action Required

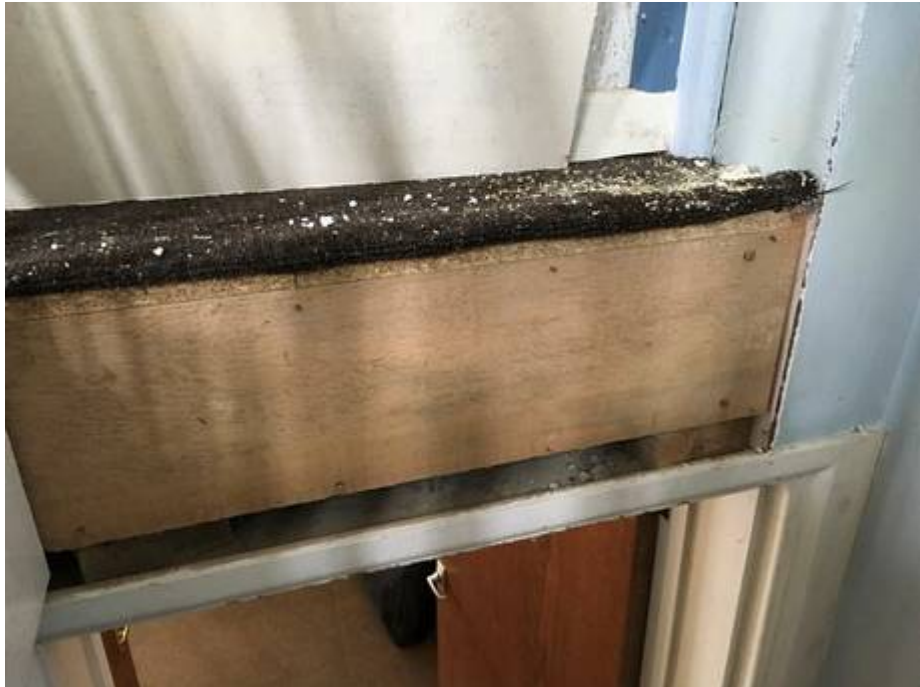
Location ID:	<input type="text" value="6091"/>	Survey Type:	<input type="text" value="RDS"/>
Location Ref:	<input type="text" value="10"/>	Product Type:	<input type="text" value="Not Applicable"/>
Product:	<input type="text"/>	Damage:	<input type="text" value="Not Applicable"/>
Area:	<input type="text" value="Gotherington Church Centre"/>	Treatment:	<input type="text" value="Not Applicable"/>
Floor:	<input type="text" value="First floor"/>	Asbestos Type:	<input type="text" value="Not Applicable"/>
Room:	<input type="text" value="Stairs Area"/>	Identification:	<input type="text"/>
Surveyor Name:	<input type="text" value="Rob Letman"/>	Quantity:	<input type="text"/>
Drawing Ref:	<input type="text"/>		
Asbestos ?	<input type="text" value="No"/>		
Date:	<input type="text" value="14 August 2017"/>		
Next Inspection:	<input type="text" value="Not Applicable"/>

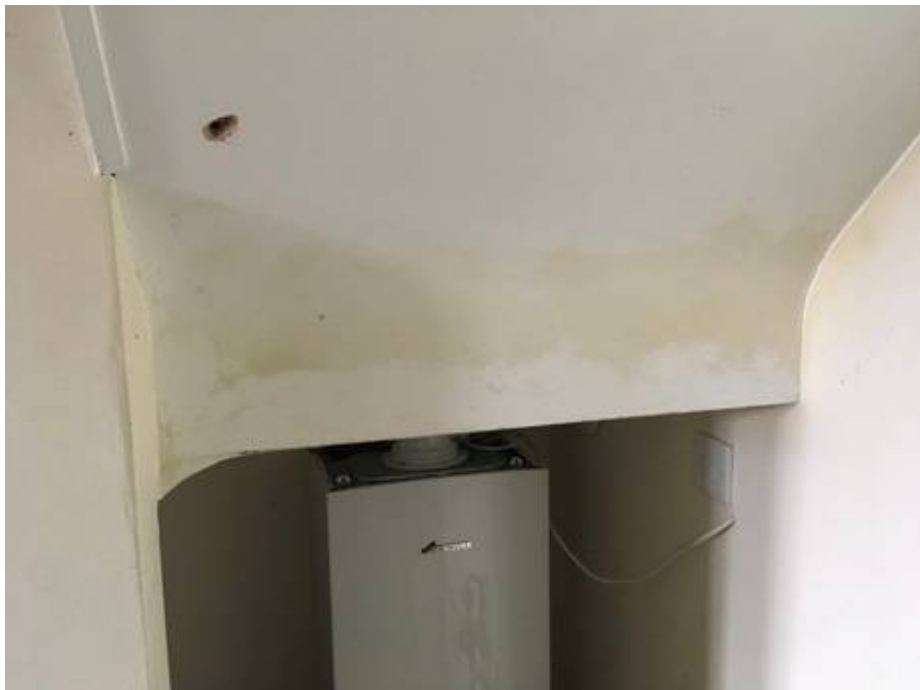
Location ID:	<input type="text" value="6092"/>	Survey Type:	<input type="text" value="RDS"/>
Location Ref:	<input type="text" value="11"/>	Product Type:	<input type="text" value="Not Applicable"/>
Product:	<input type="text" value="Boarding"/>	Damage:	<input type="text" value="Not Applicable"/>
Area:	<input type="text" value="Gotherington Church Centre"/>	Treatment:	<input type="text" value="Not Applicable"/>
Floor:	<input type="text" value="Ground floor"/>	Asbestos Type:	<input type="text" value="Not Applicable"/>
Room:	<input type="text" value="WC"/>	Identification:	<input type="text"/>
Surveyor Name:	<input type="text" value="Rob Letman"/>	Quantity:	<input type="text"/>
Drawing Ref:	<input type="text"/>		
Asbestos ?	<input type="text" value="No"/>		
Date:	<input type="text" value="14 August 2017"/>		
Next Inspection:	<input type="text" value="Not Applicable"/>

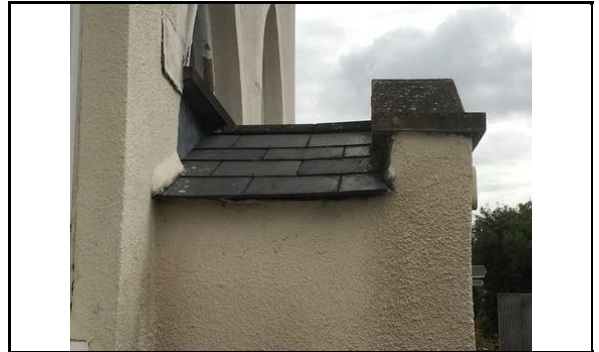
Location ID:	6084
Location Ref:	3
Product:	Sheeting
Area:	Gotherington Church Centre
Floor:	External
Room:	Front entrance
Surveyor Name:	Rob Letman
Drawing Ref:	
Asbestos ?	Yes
Date:	14 August 2017

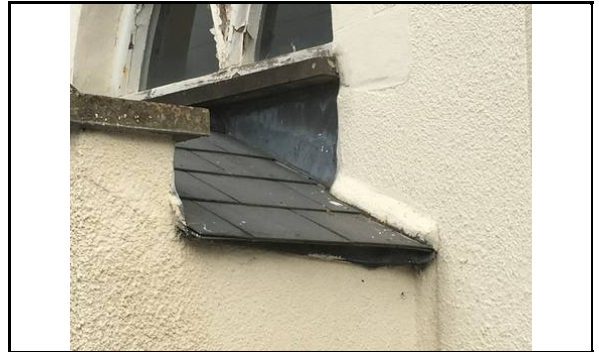
Location ID:	6085
Location Ref:	4
Product:	Sheeting
Area:	Gotherington Church Centre
Floor:	External
Room:	Front entrance
Surveyor Name:	Rob Letman
Drawing Ref:	
Asbestos ?	Yes
Date:	14 August 2017

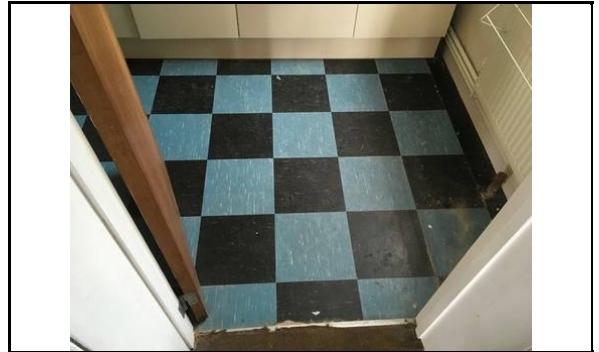
Location ID:	6087
Location Ref:	6
Product:	Vinyl Floor Tiles
Area:	Gotherington Church Centre
Floor:	Ground floor
Room:	Kitchen
Surveyor Name:	Rob Letman
Drawing Ref:	
Asbestos ?	Yes
Date:	14 August 2017
